# Yarra Ranges'

## WSUD Transformation

Presentation by **Matt Pilcher** &  
**Patrick Jeschke**, June 2019

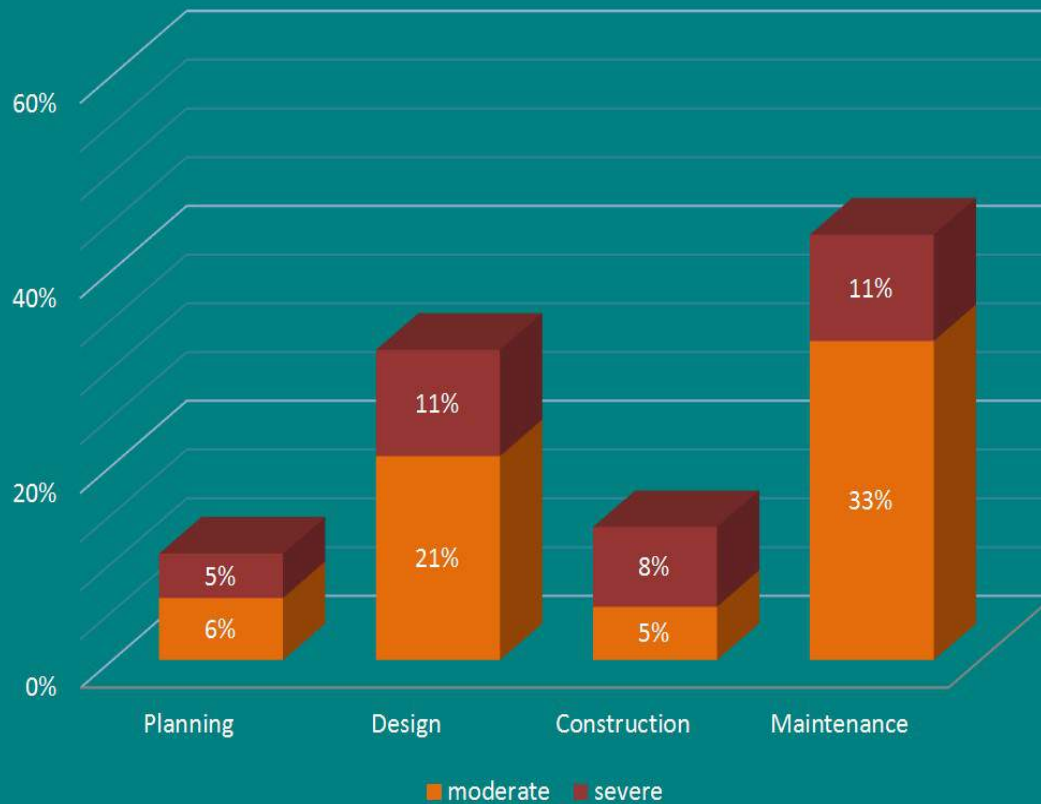
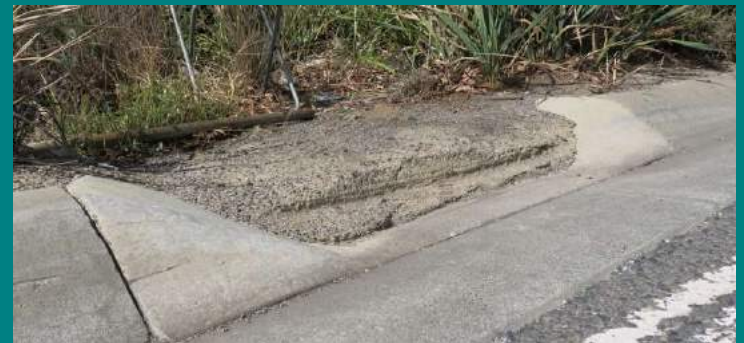
Maintenance failure

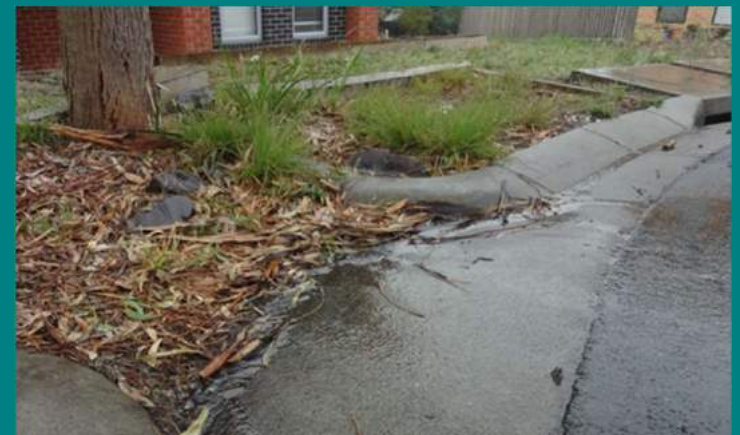
Design/construction failure

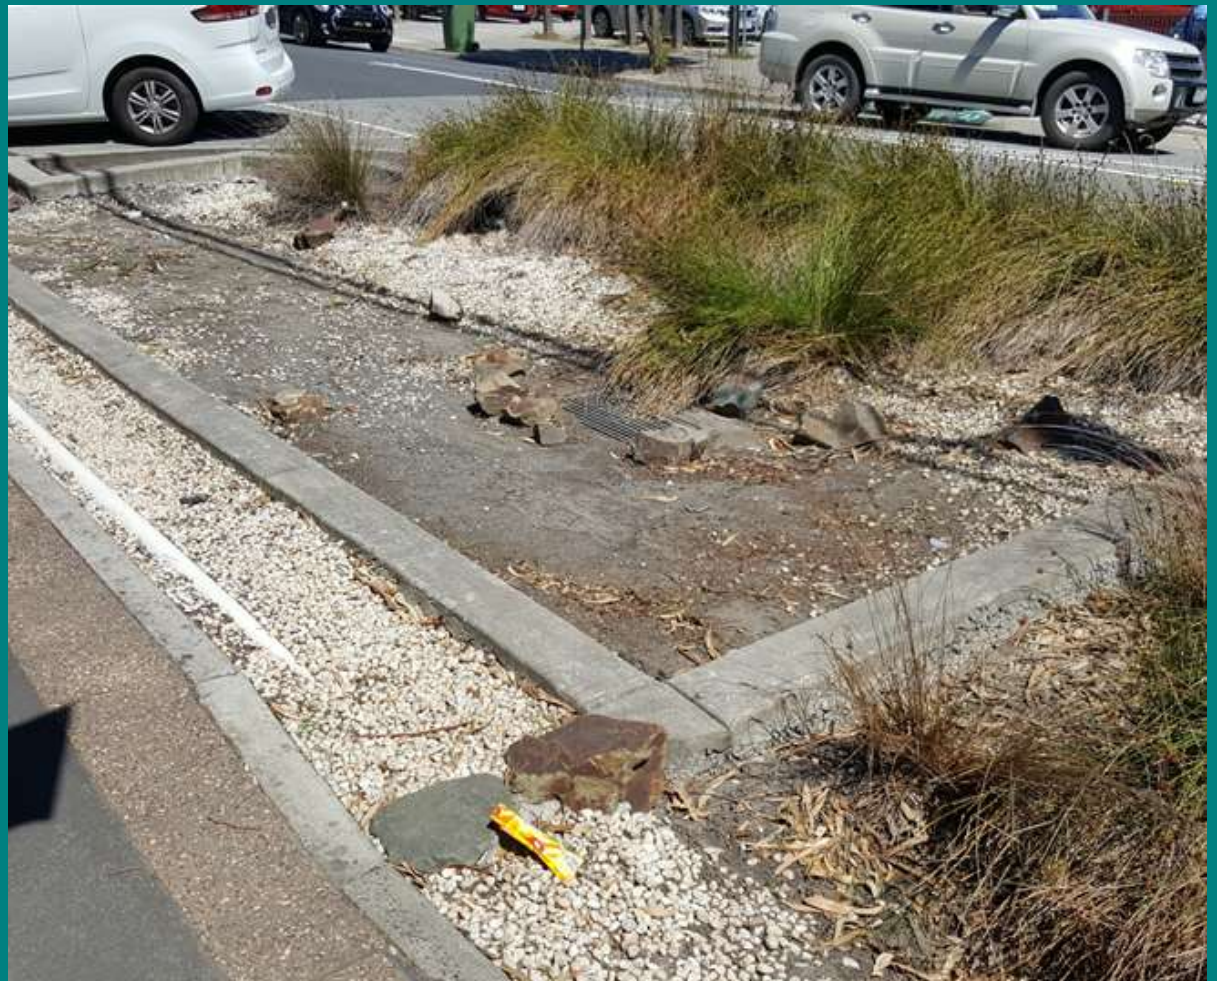
### Bayview Road Raingarden, Belgrave

- Terminal drainage point
- In-line with high-flow path
- Constructed on slope
- No extended detention depth
- No more filter vegetation
- Footpath flooding

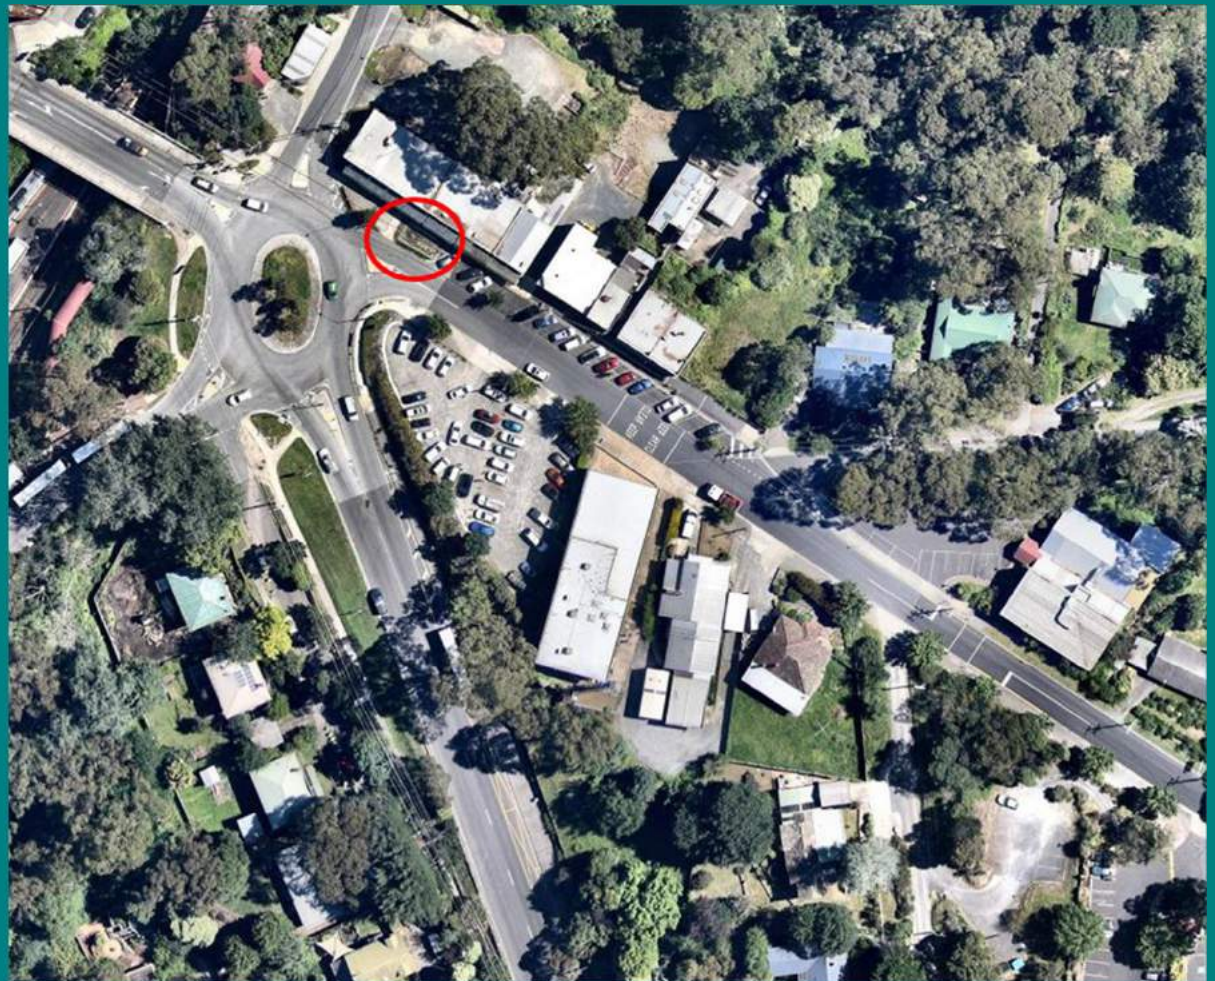
## Bayview Road Raingarden, Belgrave

- Terminal drainage point
- In-line with high-flow path
- Constructed on slope
- No extended detention depth
- No more filter vegetation
- Footpath flooding

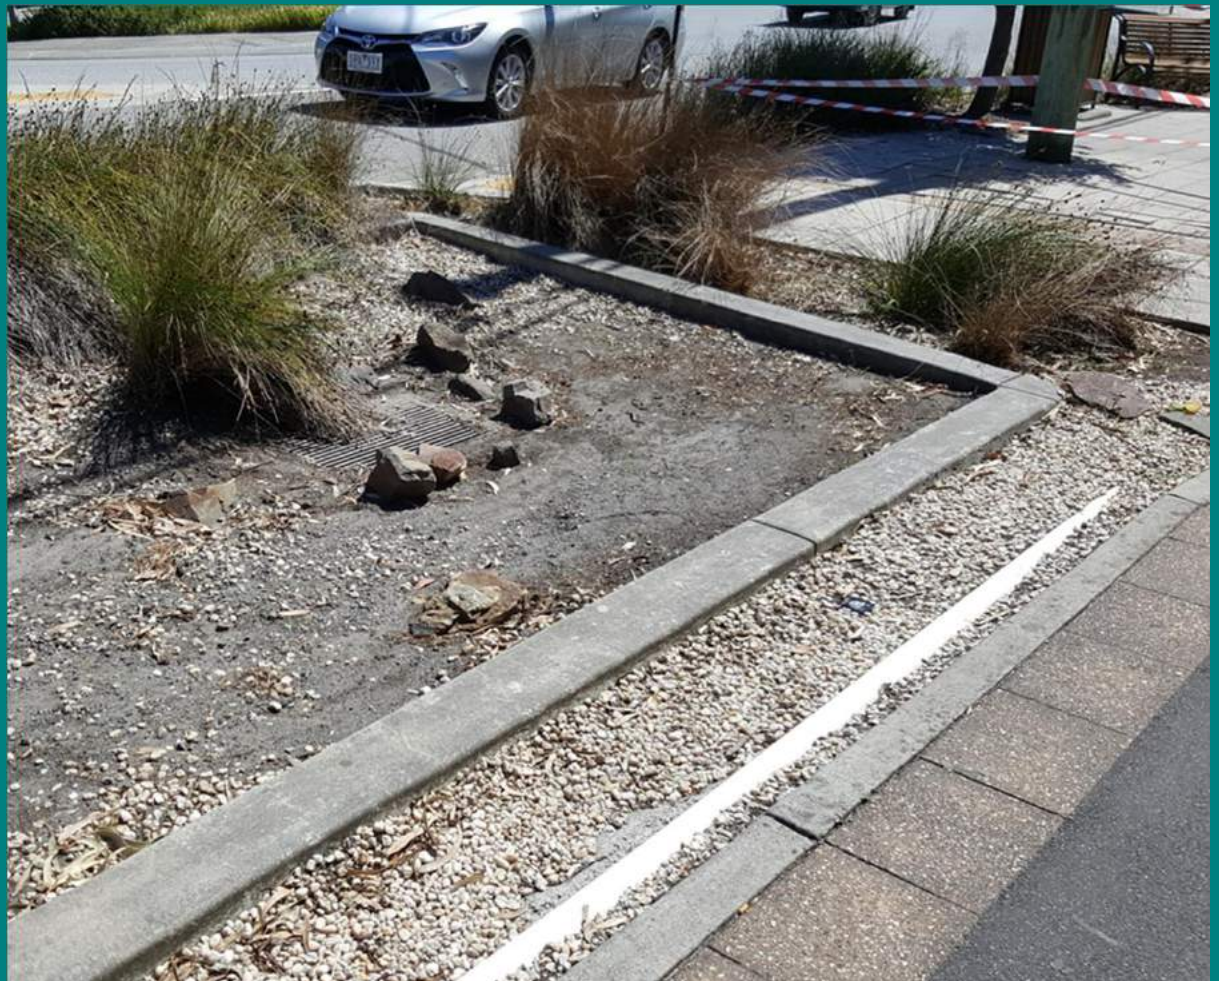
### Bayview Road Raingarden, Belgrave

- Terminal drainage point
- In-line with high-flow path
- Constructed on slope
- No extended detention depth
- No more filter vegetation
- Footpath flooding

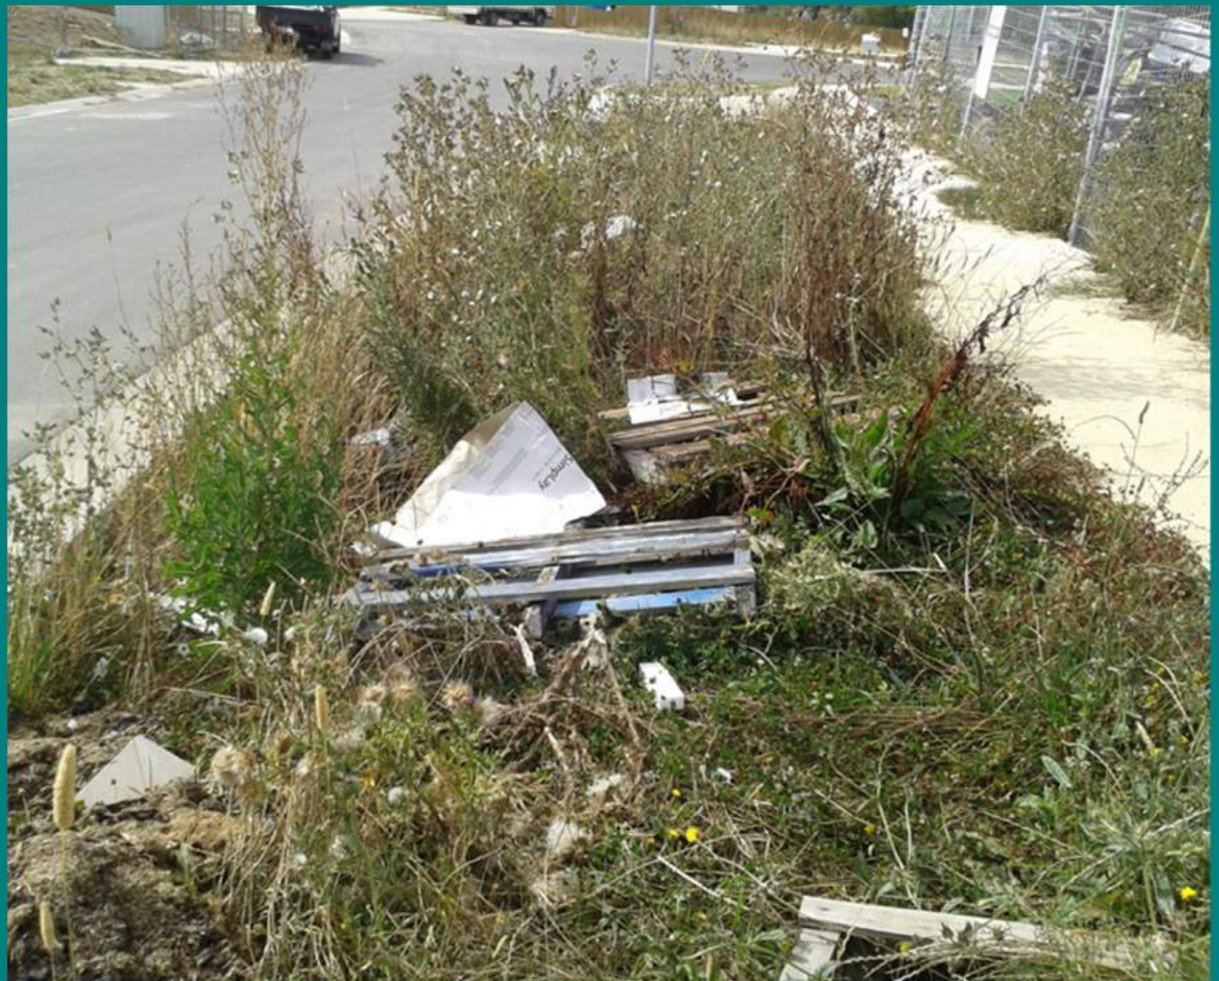
## Cruz Court Raingardens, Yarra Glen

- Inherited through subdivision
- Almost everything was wrong with them!
- Safety risk
- Ongoing lot development

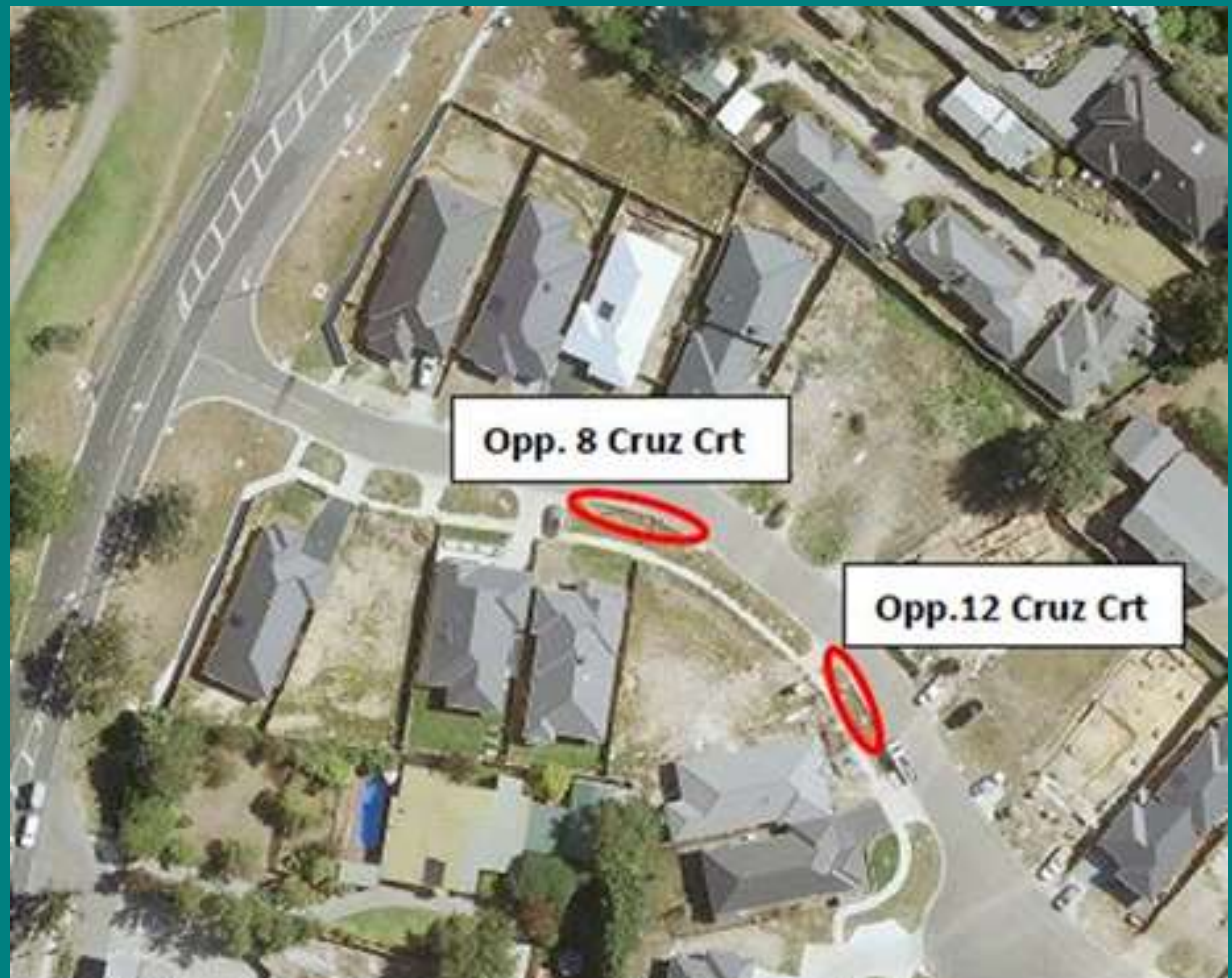
Planning and design issues:

- Catchment area
- Unsafe design

1 Rectified

1 Decommissioned to passive garden bed

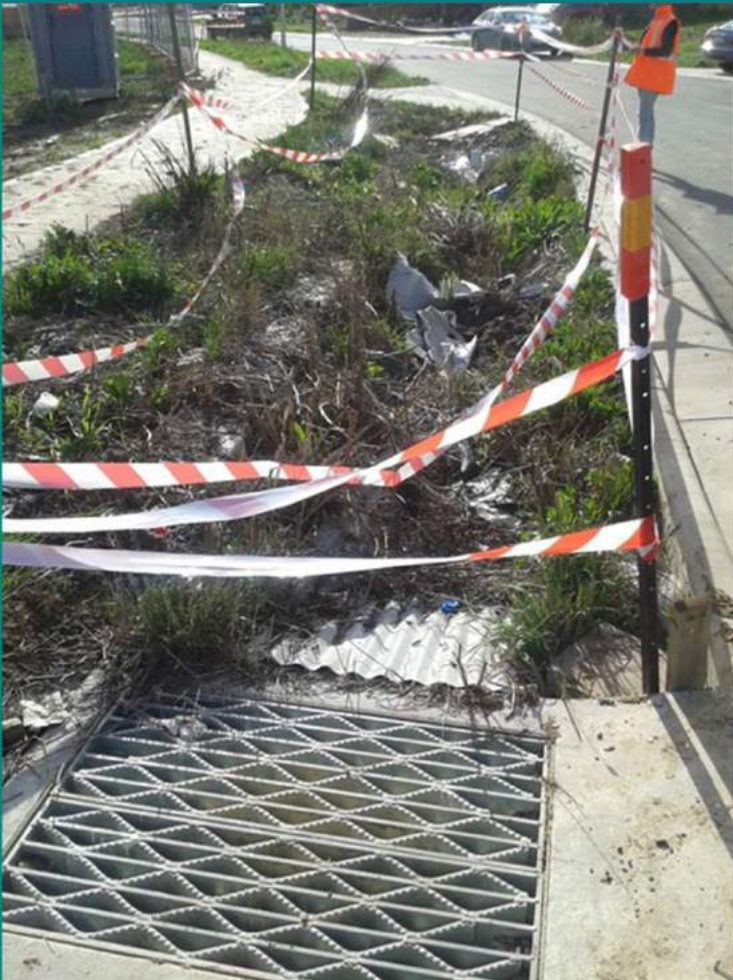
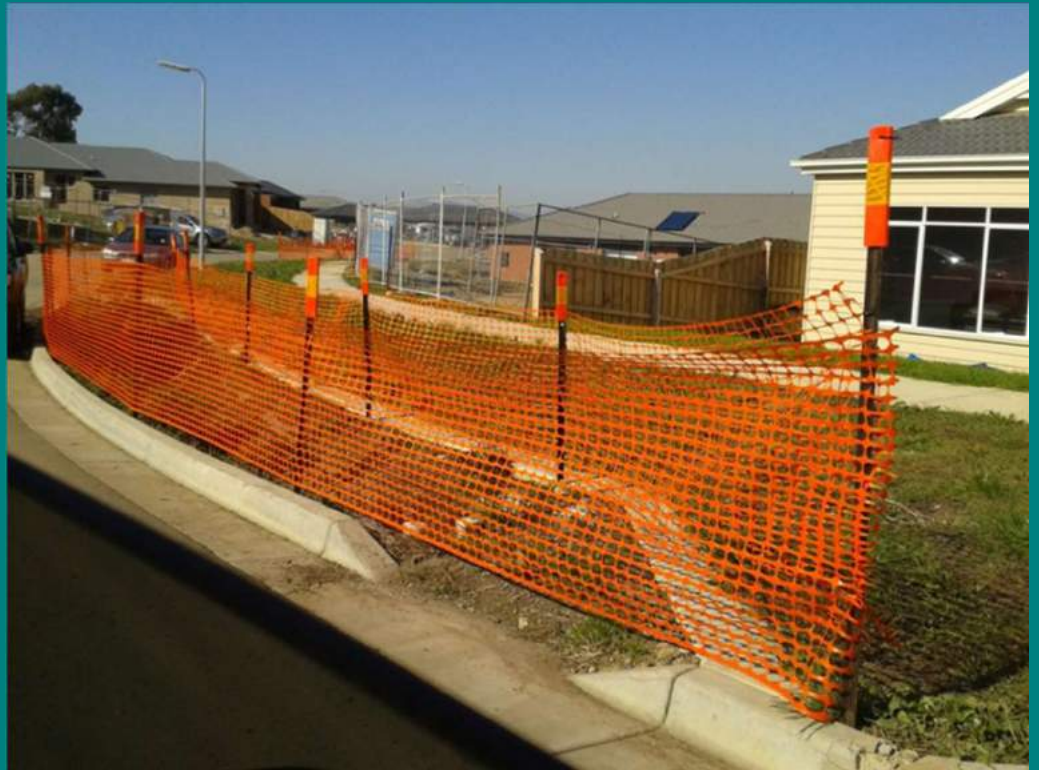
**Resident Safety Complaints!**
