All The Things We Learnt – Dandenong Council Stormwater Quality Audit

Background

- “A comprehensive condition assessments of Council owned Gross Pollutant Trap (GPT) and wetland assets to allow CGD to proactively plan for the maintenance and/or capital replacement and renewal of Council assets”
- 32 GPT Assets
- (15 CleansAlls, 13 CDS Units, 3 Ecosols, 1 Humegard)
- 2 Wetland Assets

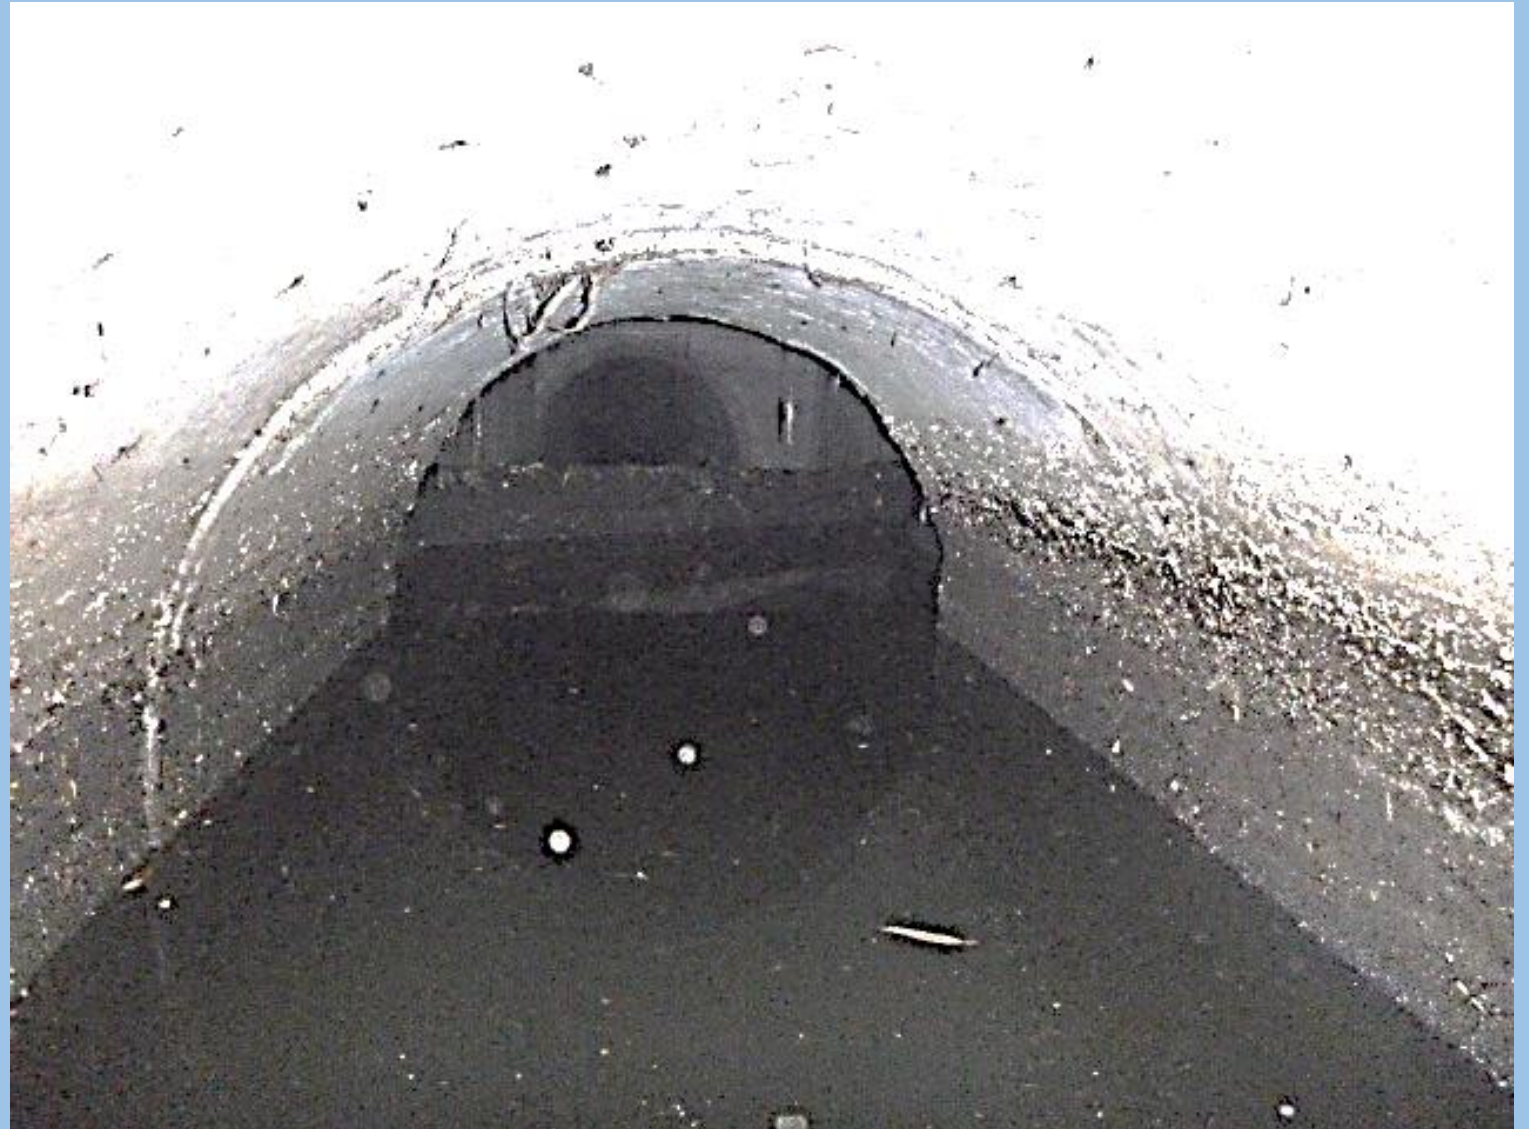
- Clow Street CDS blocked up to 900mm causing backwater on the pipe network and odour issues . Pollution is not able to be treated when the device is full behind the screens

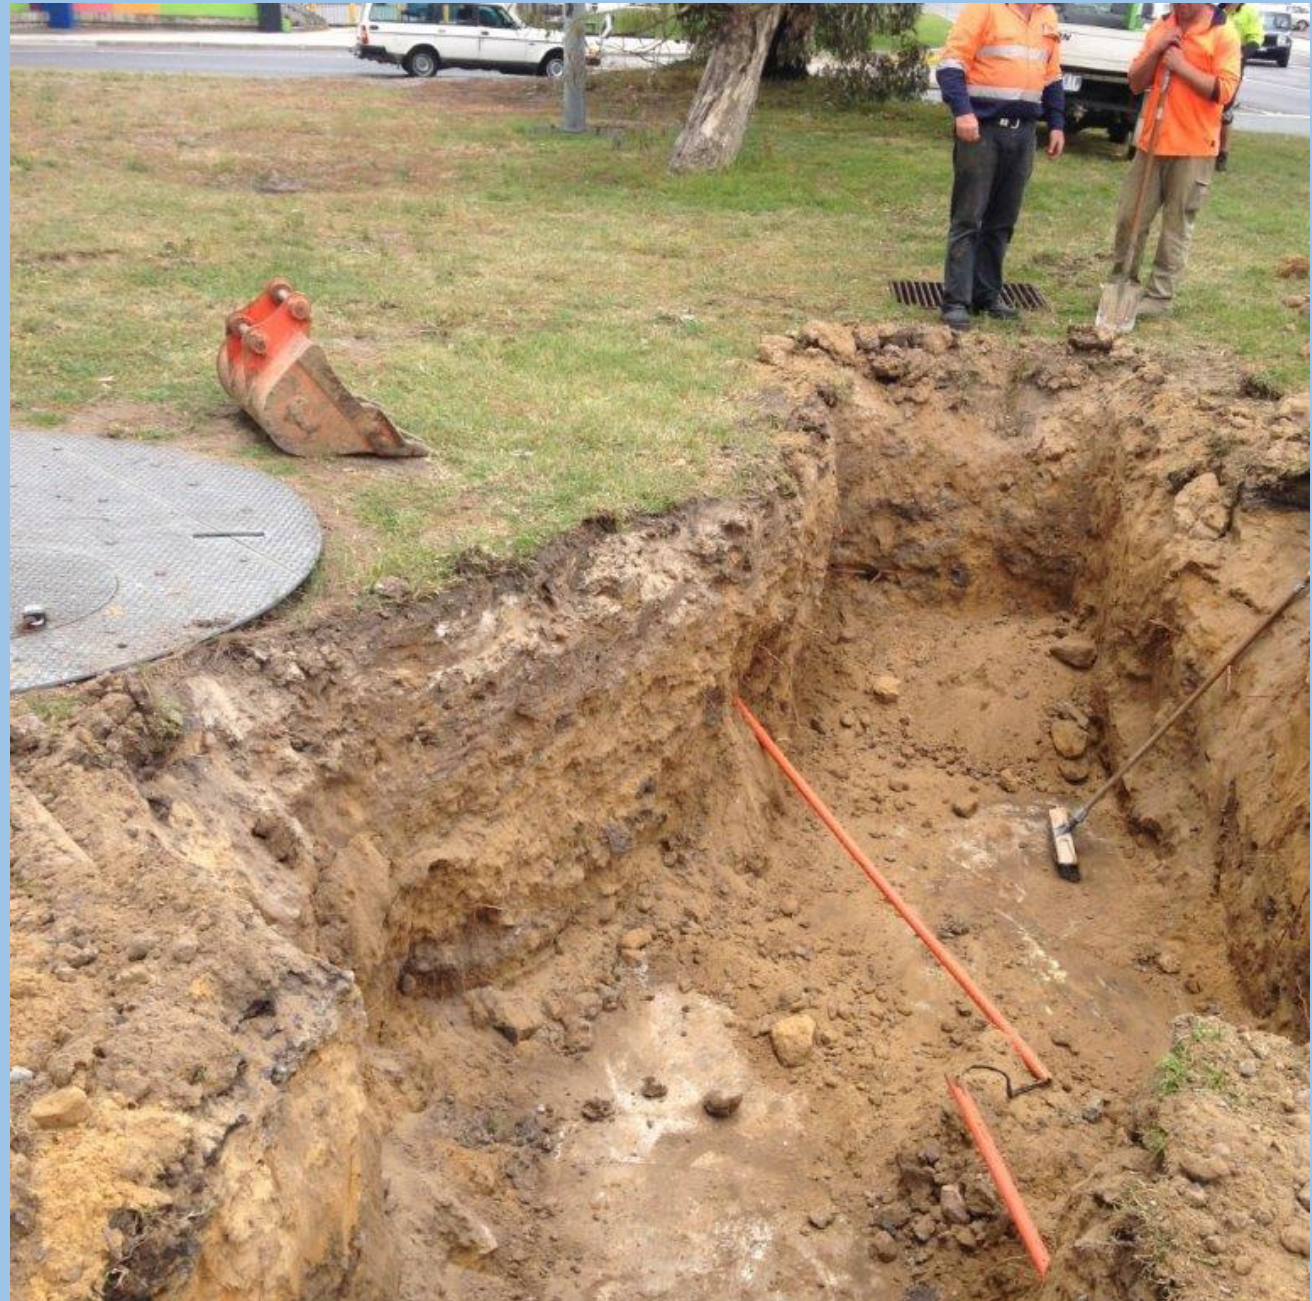
- Clow St CDS – there is no access into the roof of the diversion chamber at the location shown so that behind the screens can be suction cleaned to remove pollution that has likely been there for 20 years. Once behind the screens is cleaned, flows can be treated and odour likely improved.

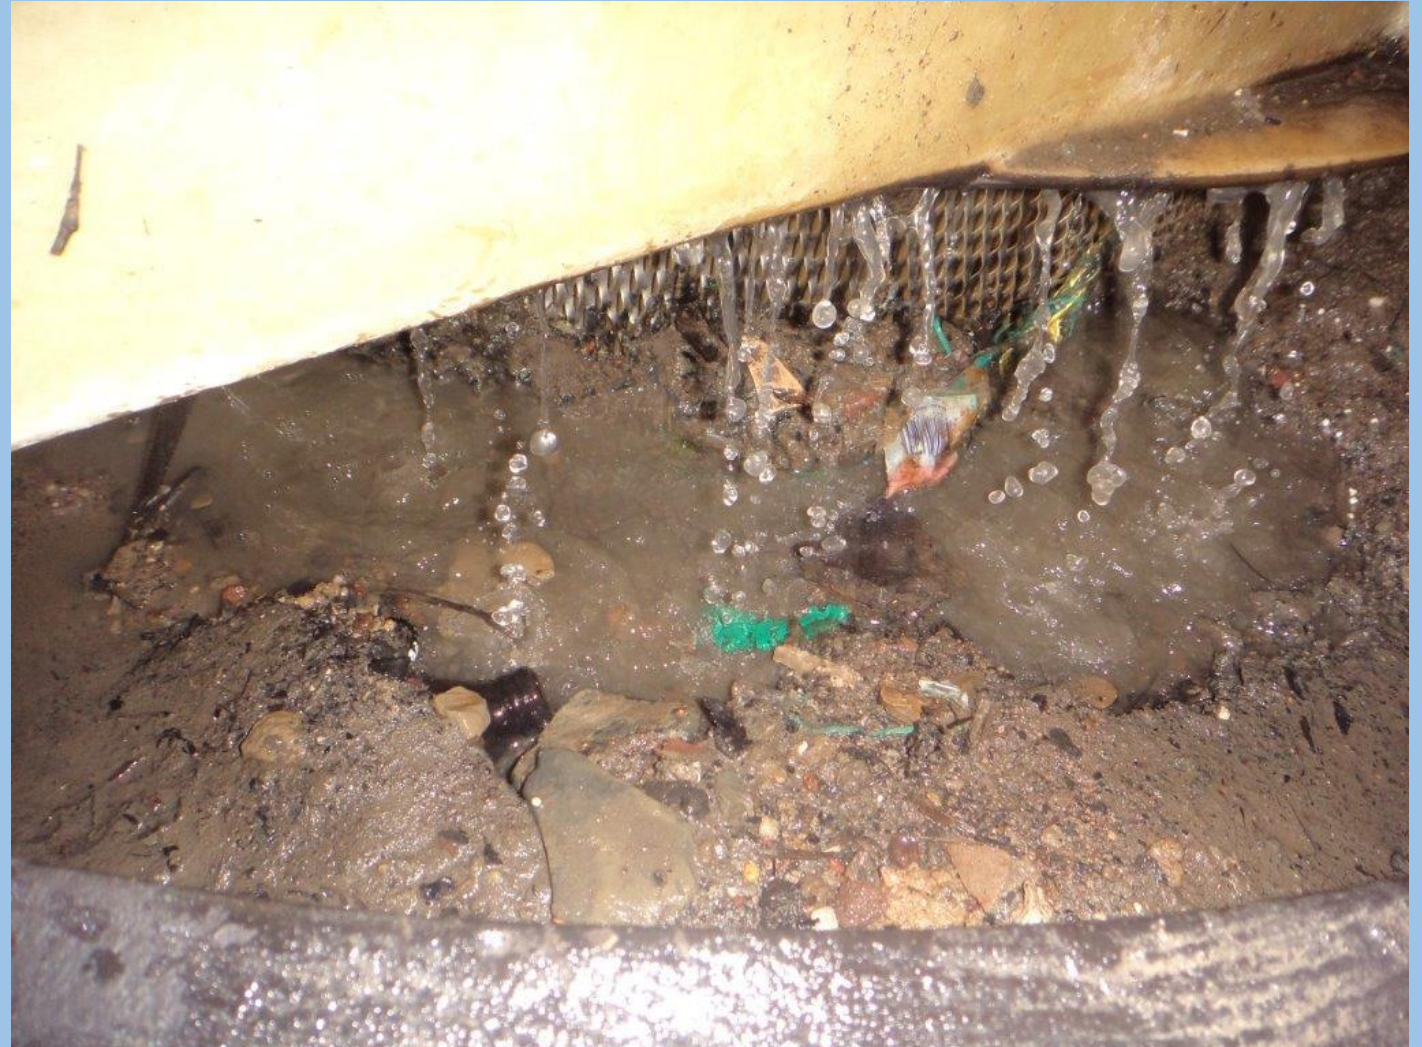
- Example of CDS full behind the screens – 200% full behind the screens and no treatment occurring. Cleaning behind the screens is a must for every CDS unit and must be specified in a cleaning tender

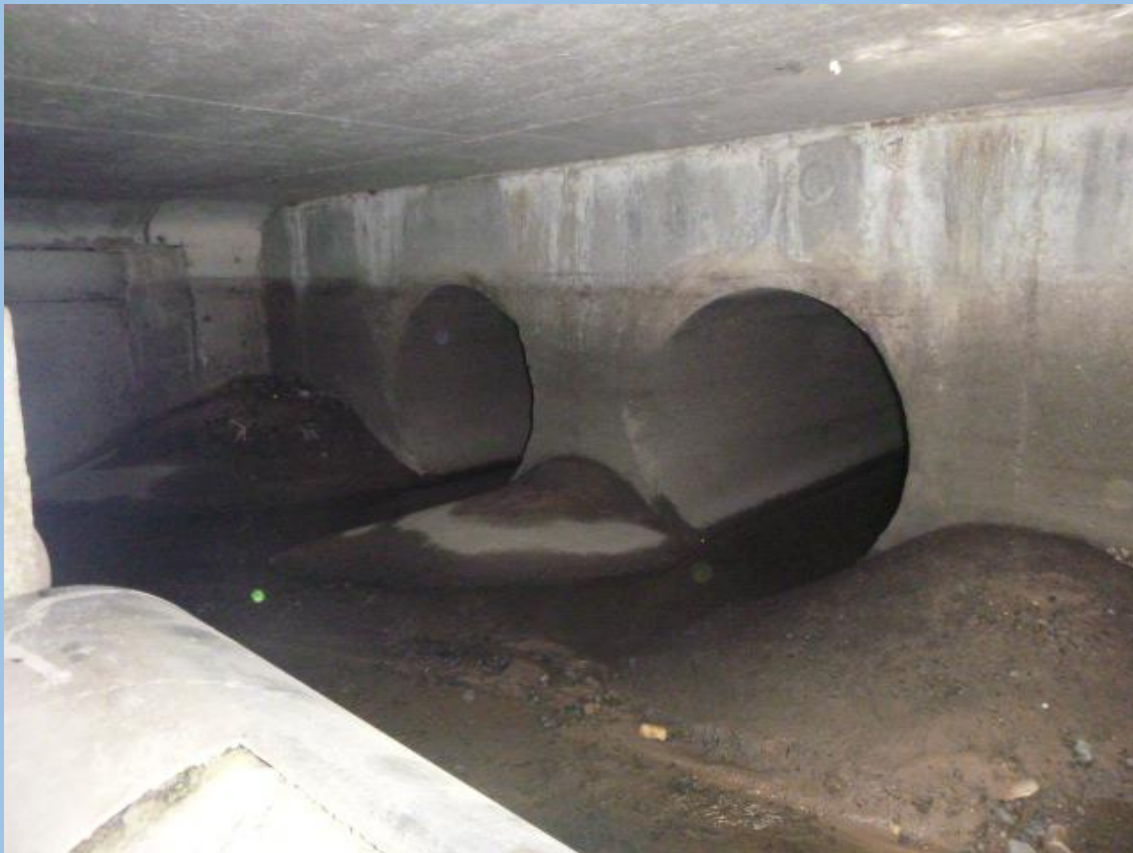
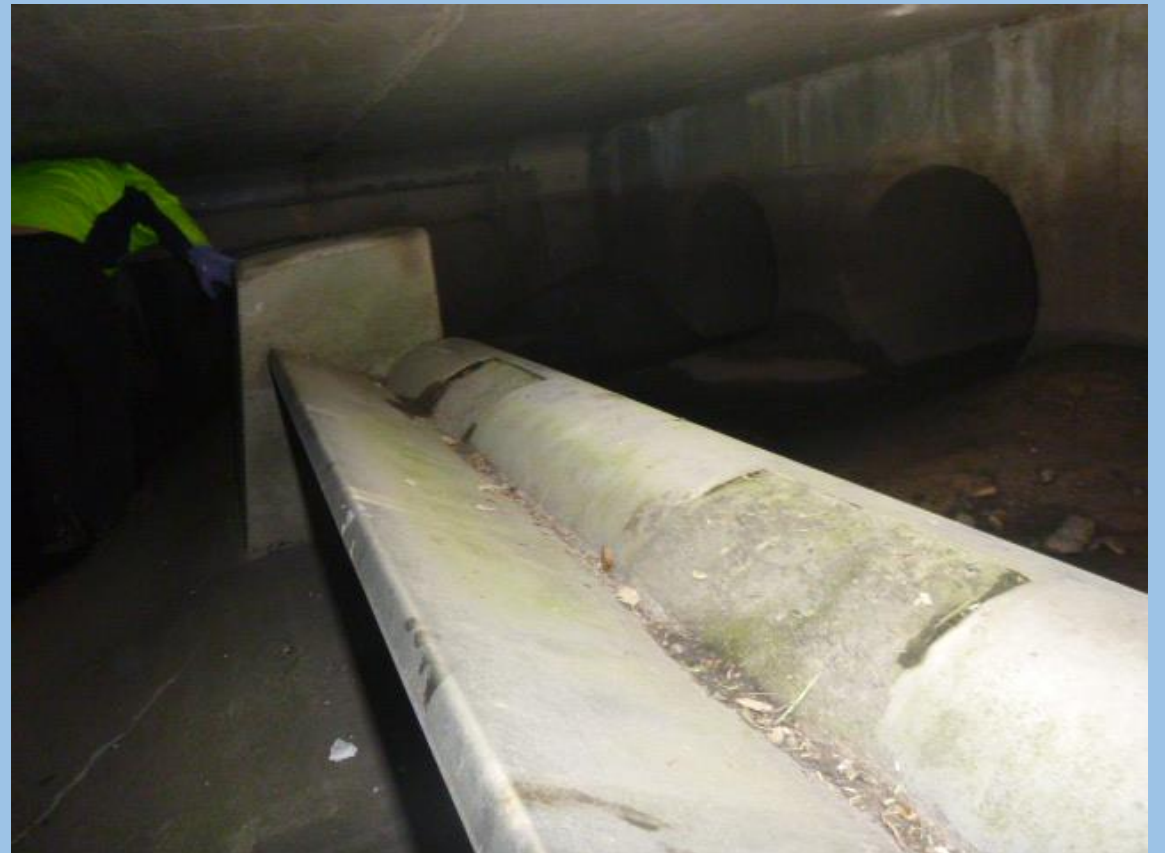
- Flinders St CDS – collapsible weirs permanently open, evidence of pollution build-up blocking the upstream pipes, no low flow bypass – requires new solid weir and CDS m3 storage increasing for large catchment

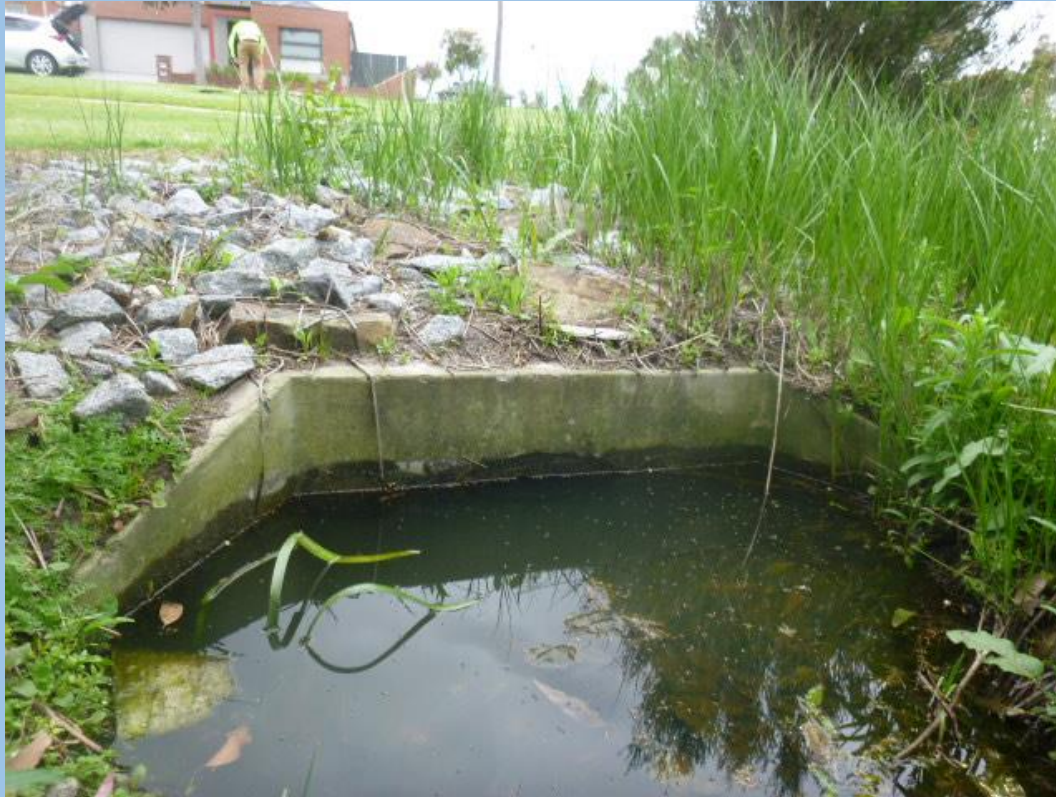
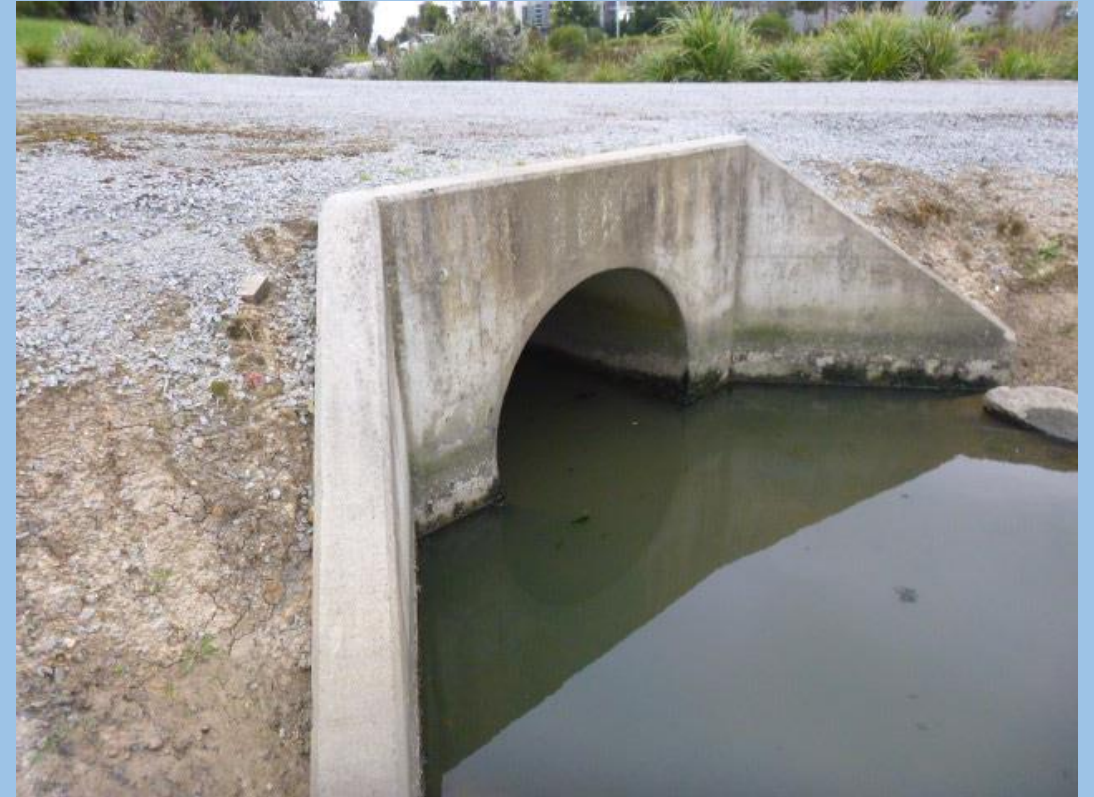
- Backwater on CDS at Arkwright Drive and CleansAll at Cafardi Blvd and making the devices difficult to clean unless the backwater is removed..

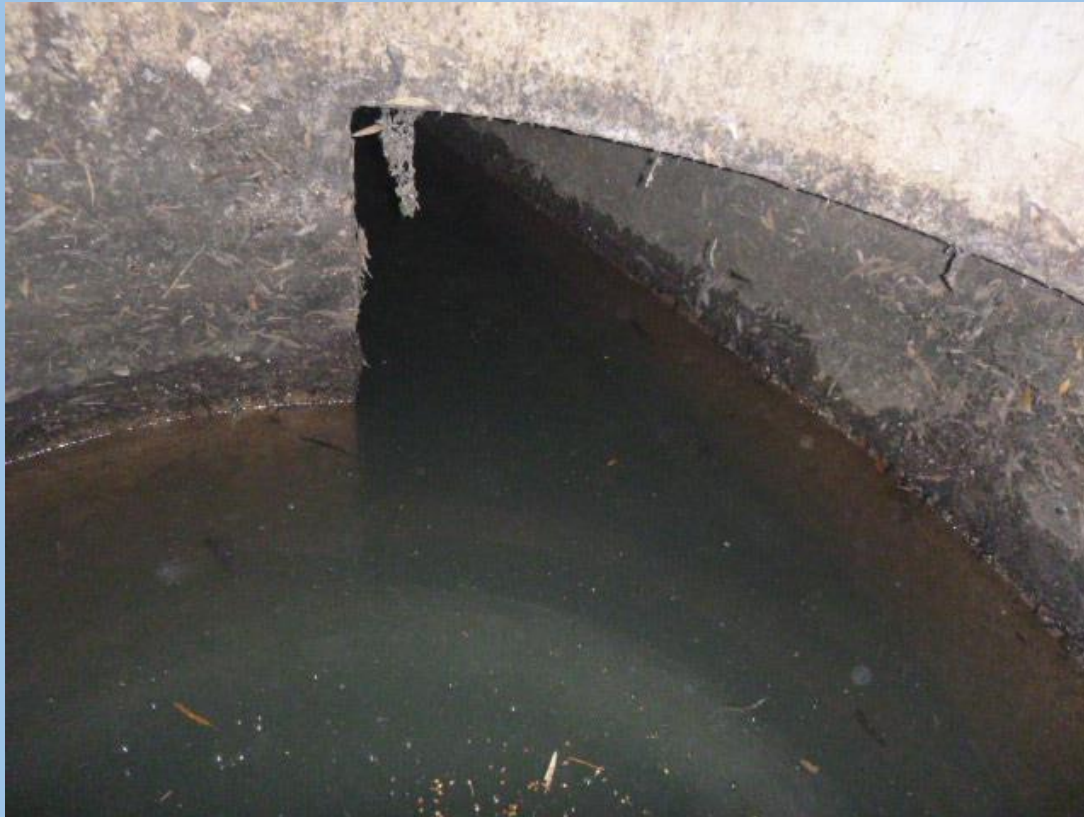
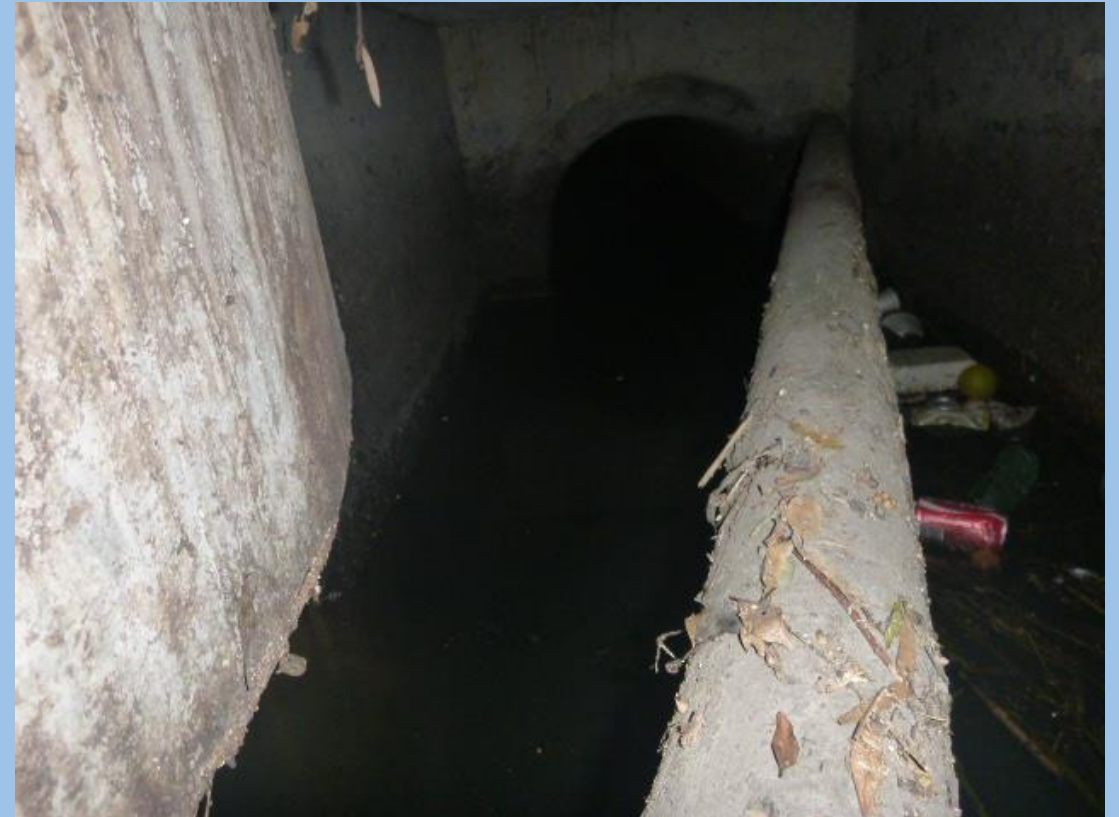
- Monash Drive CleansAll – backwater on device but device can be basket lifted, however pollution is on the wrong side of the weir..

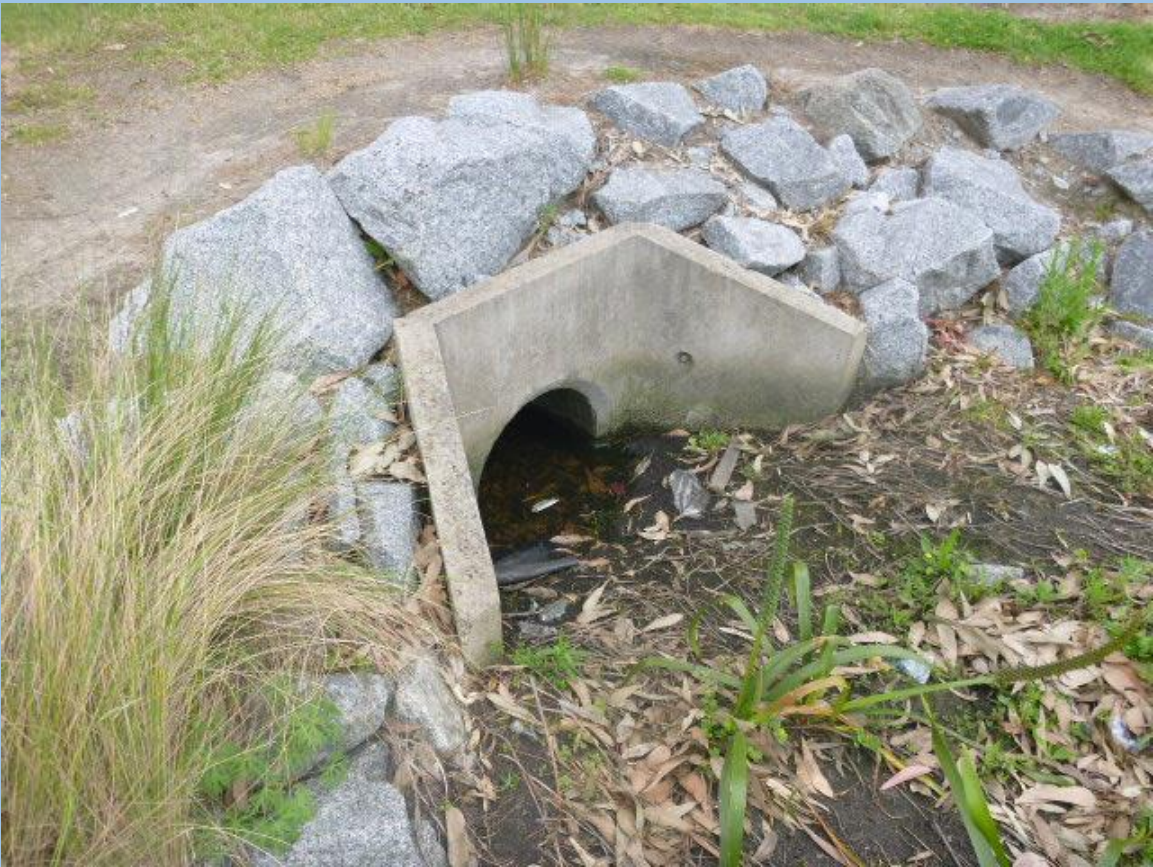
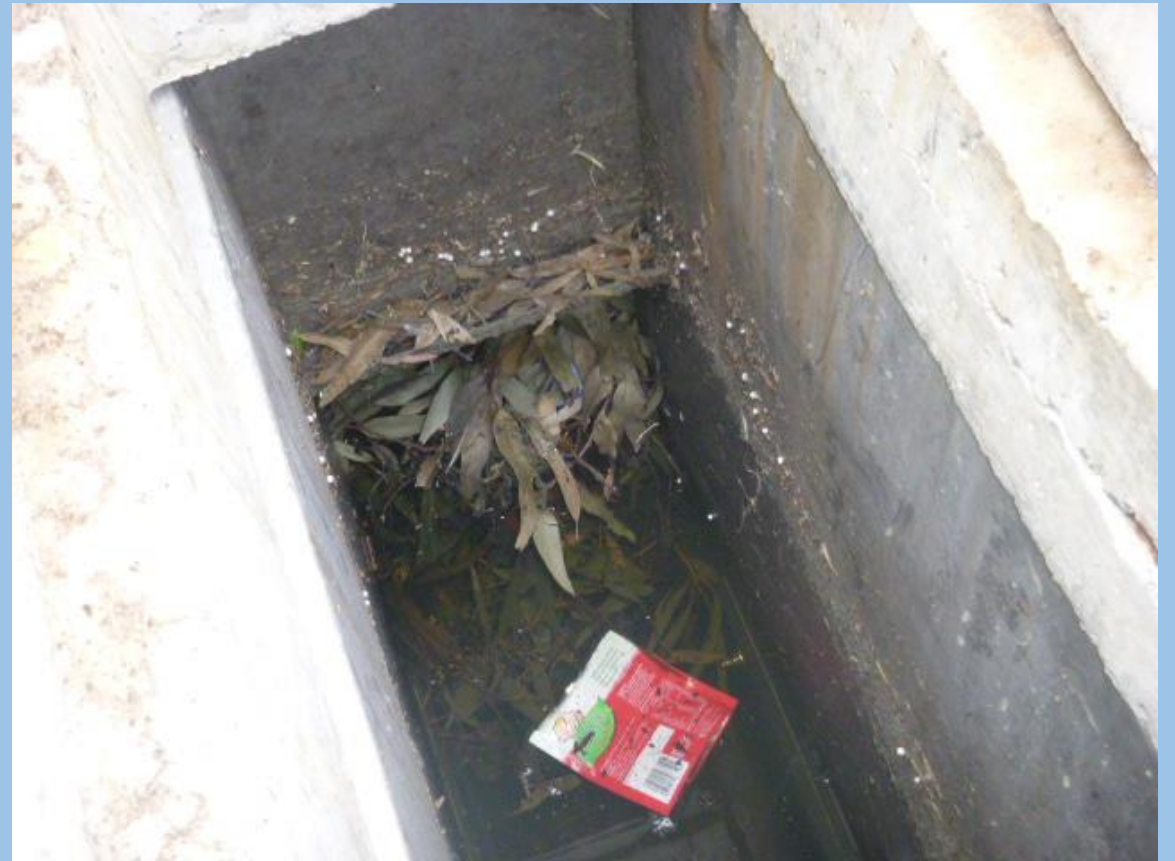
- Dandenong Ecosols – generic Ecosol problems however outlet must be cleared for them to work, however they wont work well unless rectified

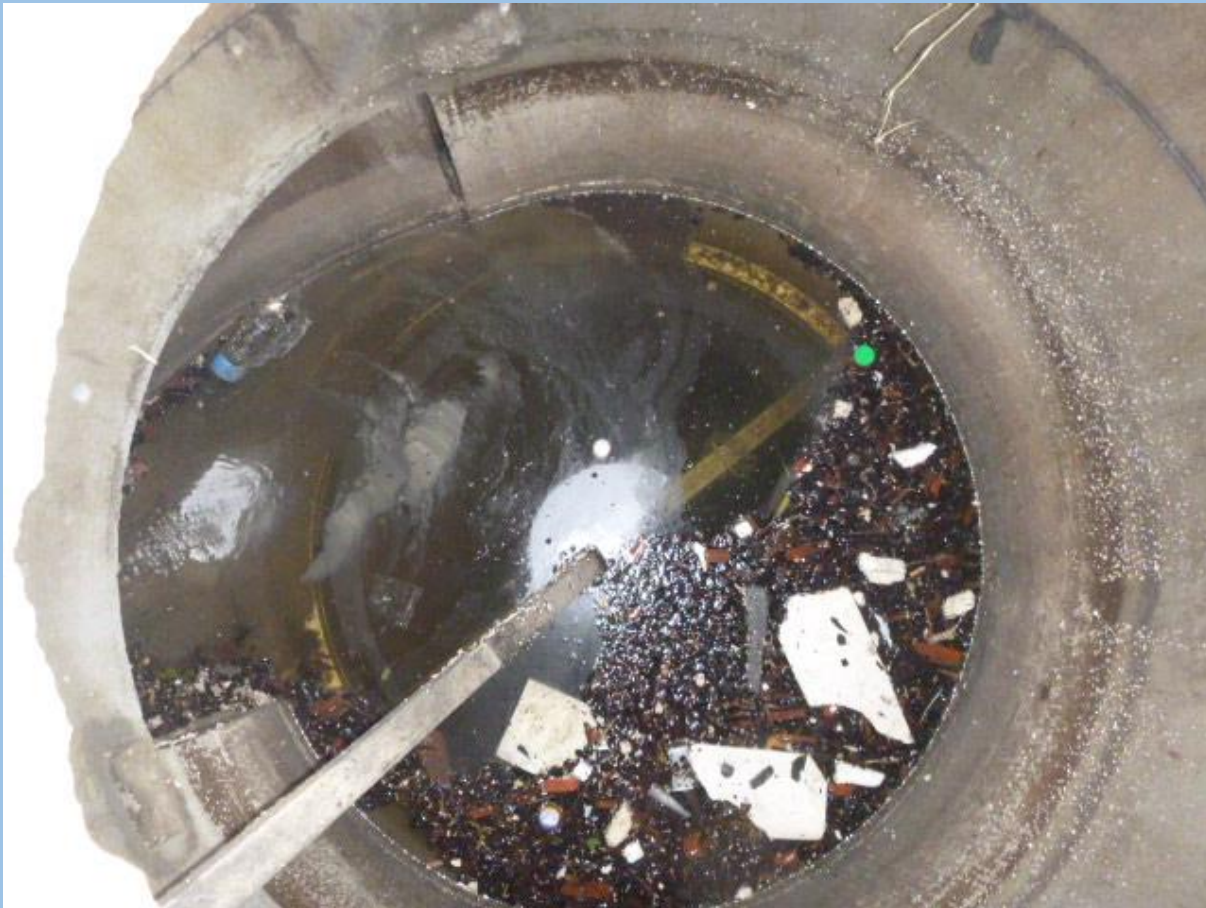
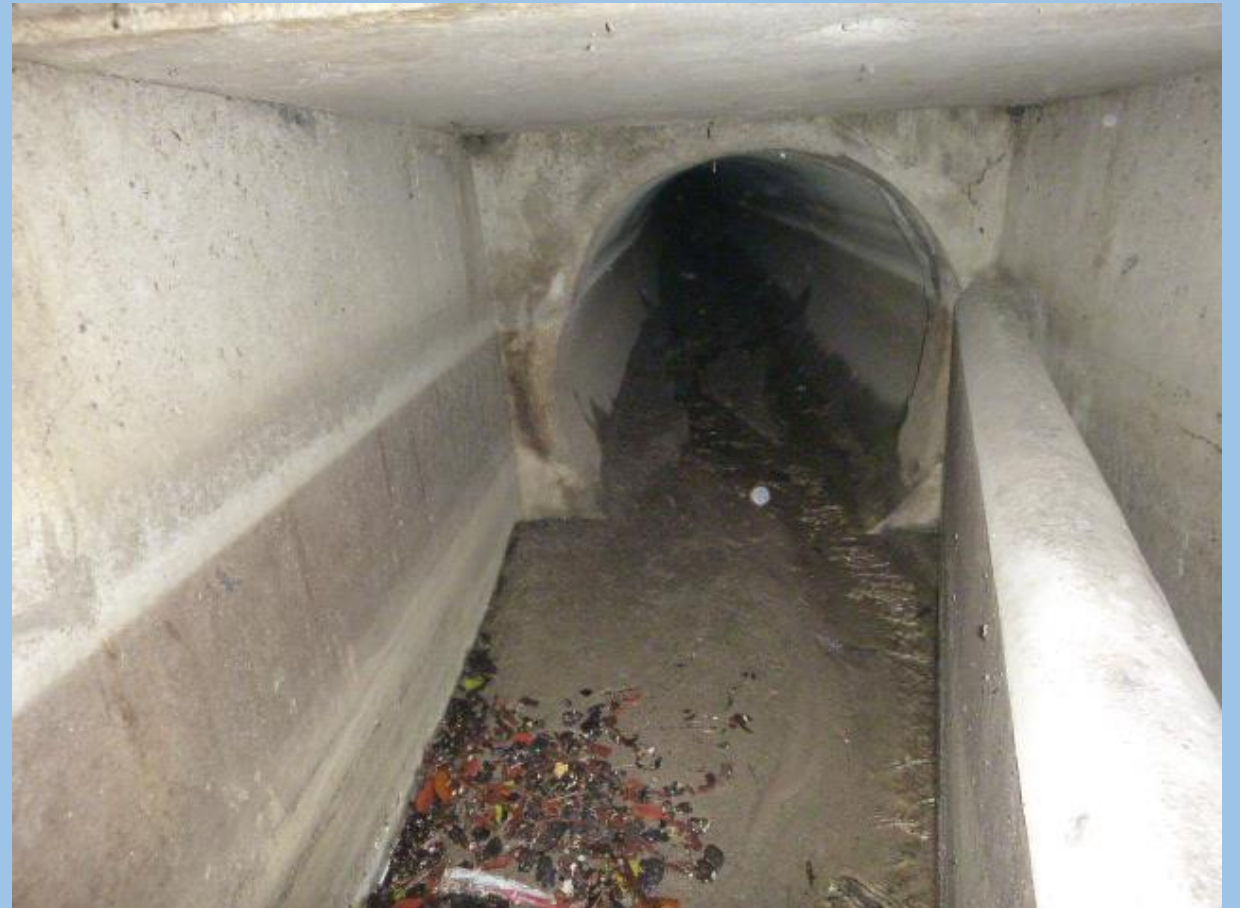
- CleansAlls undersized for the catchment areas – tide lines as proof of blocked pipelines and basket cleaning should be suction cleaning instead

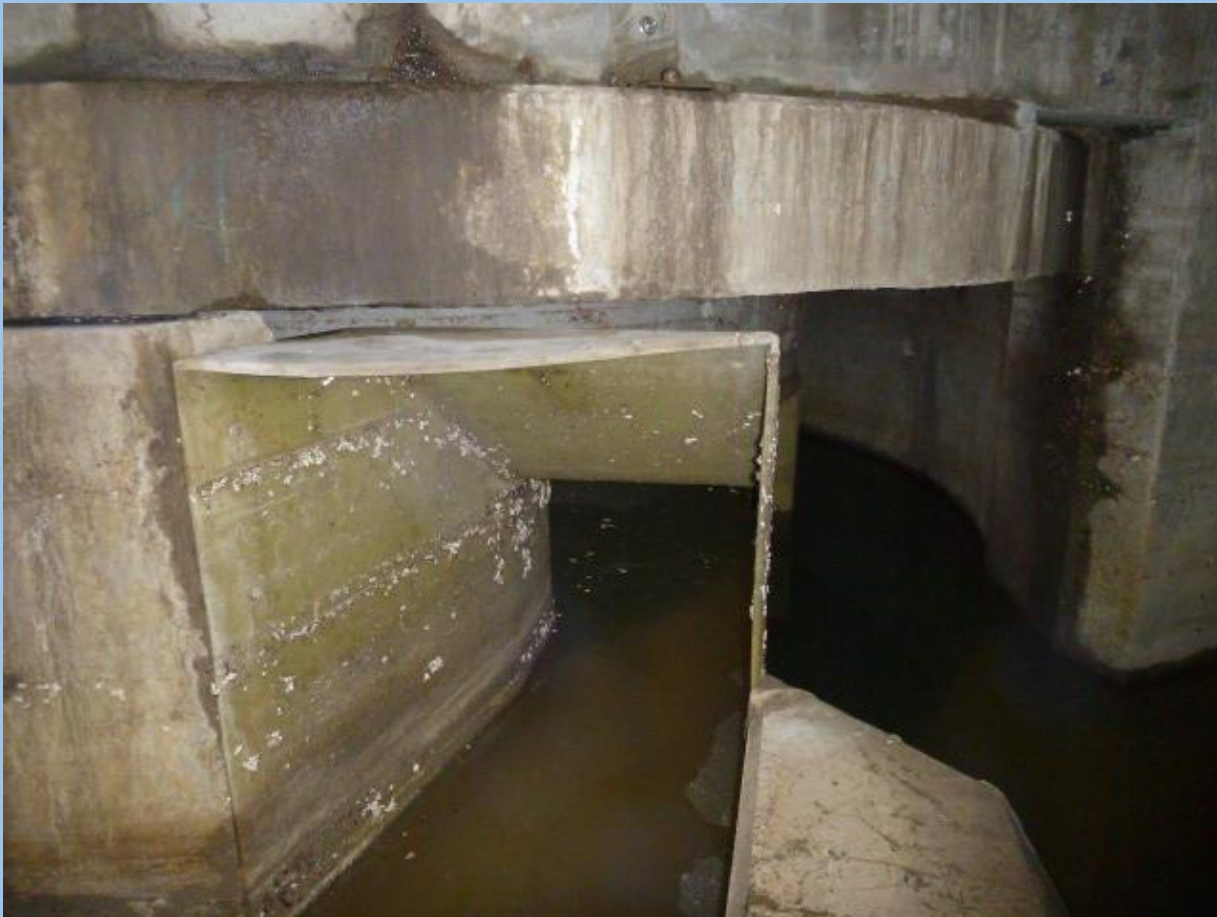
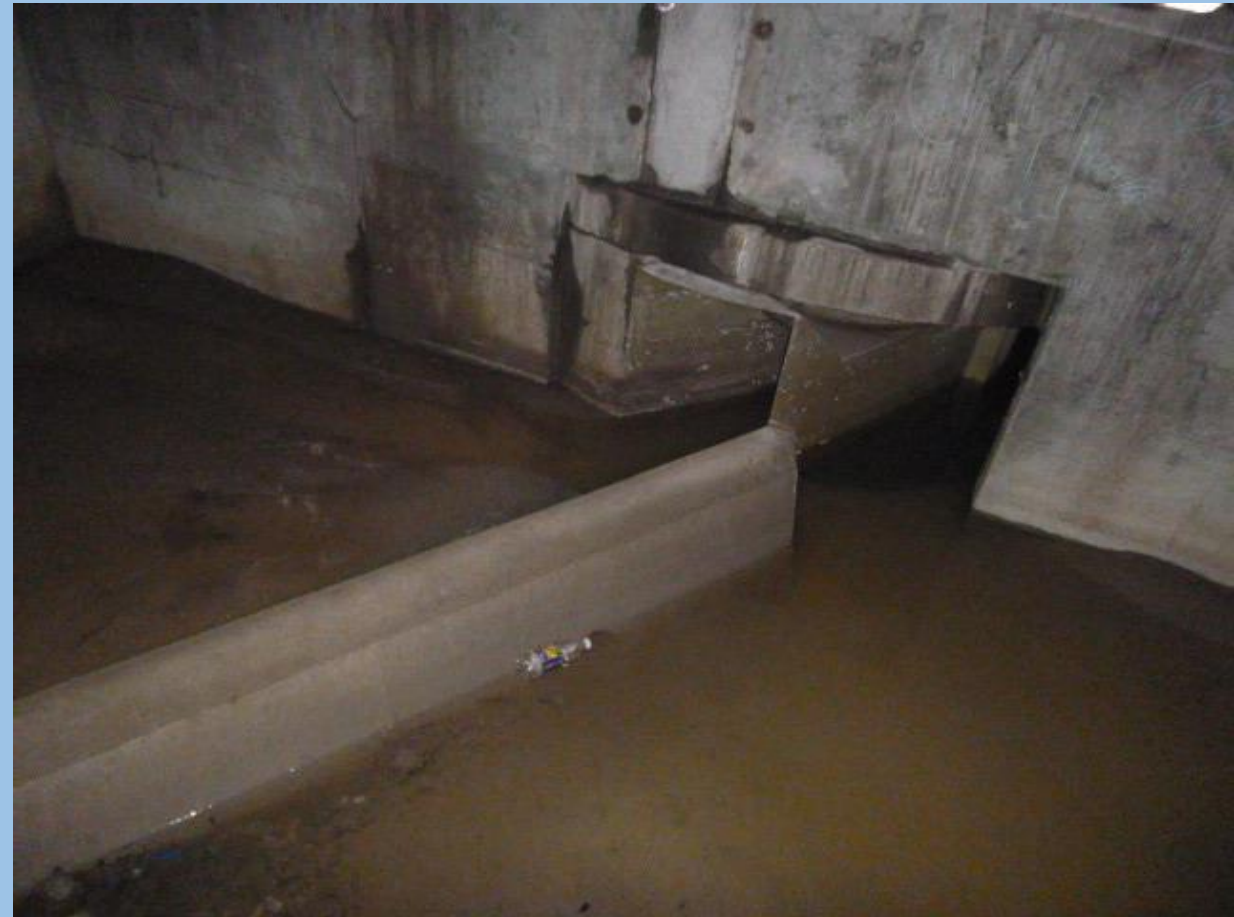
- CDS weir height too low – will lose pollutants and must be raised

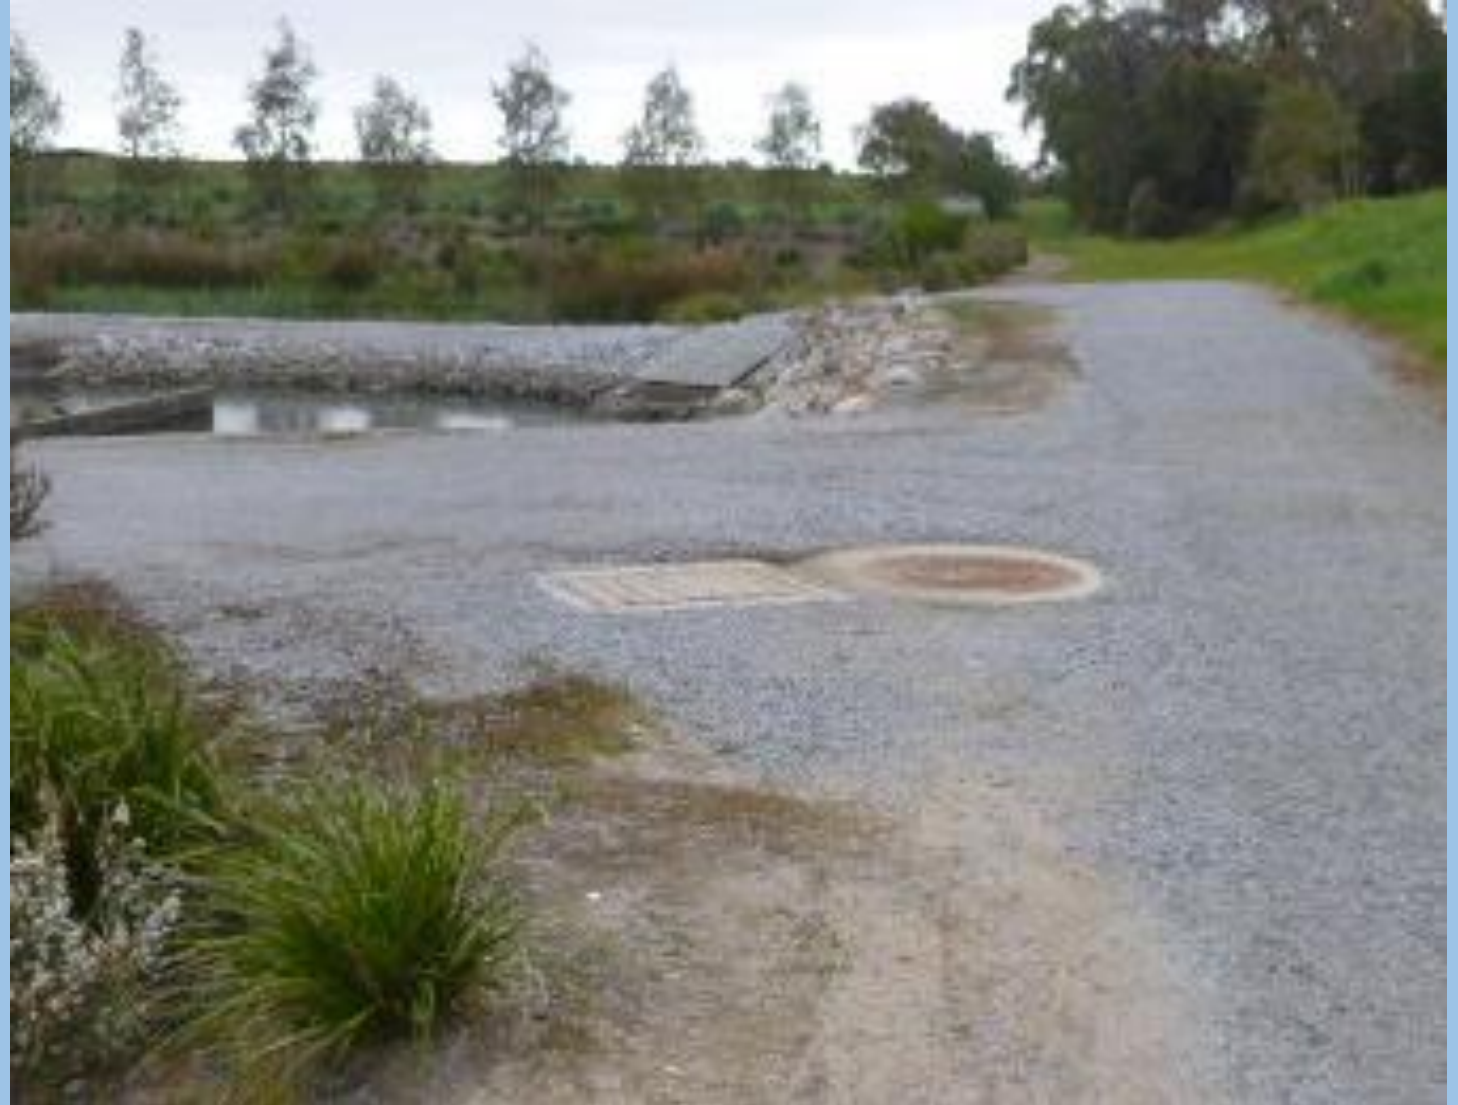
- Arkwright Drive CDS – there is not a CDS swirl lid over the top of the device – it is a 900 x 900 gatic lid and this cannot be used for grab cleaning. As the device has backwater, it cannot be suction cleaned and must be grab cleaned. To do this, a new 2m diameter circular lid is required and the square gatic lid removed.

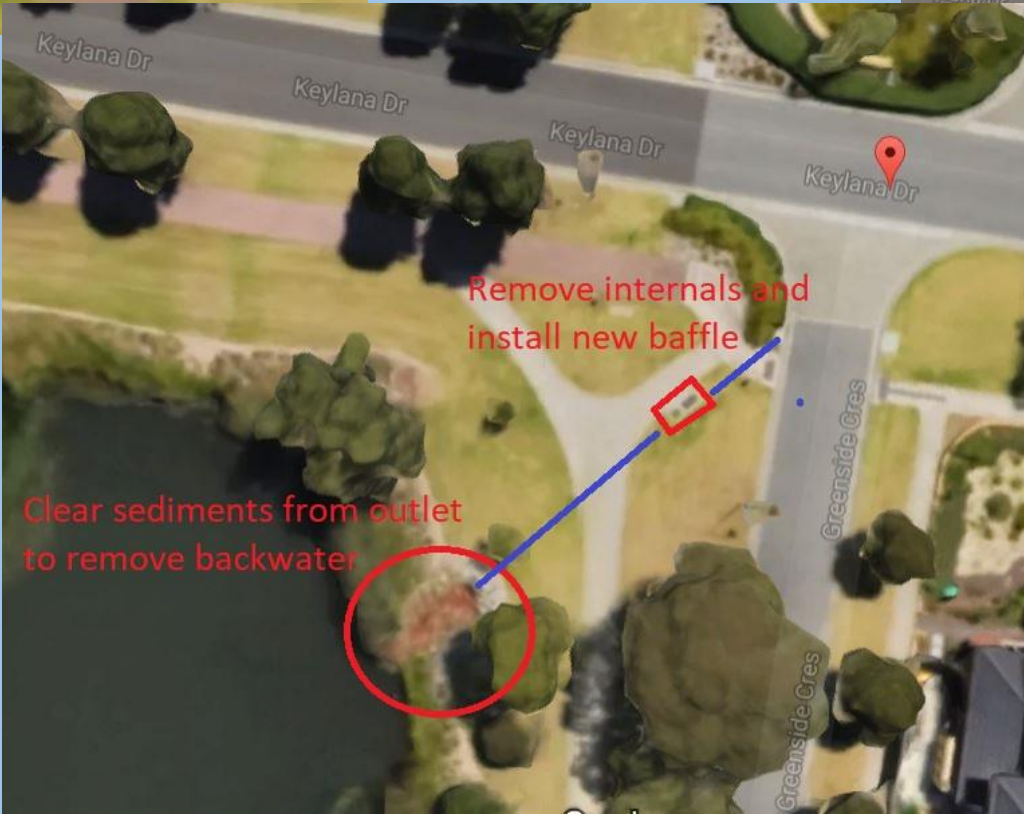
Remove internals and
install new baffle

Clear sediments from outlet
to remove backwater
